# Middelburg Heritage: This week in Middelburg's History – March 30

The Kruithuis (Arsenal) – Oldest government building in Middelburg - 30 March 1875

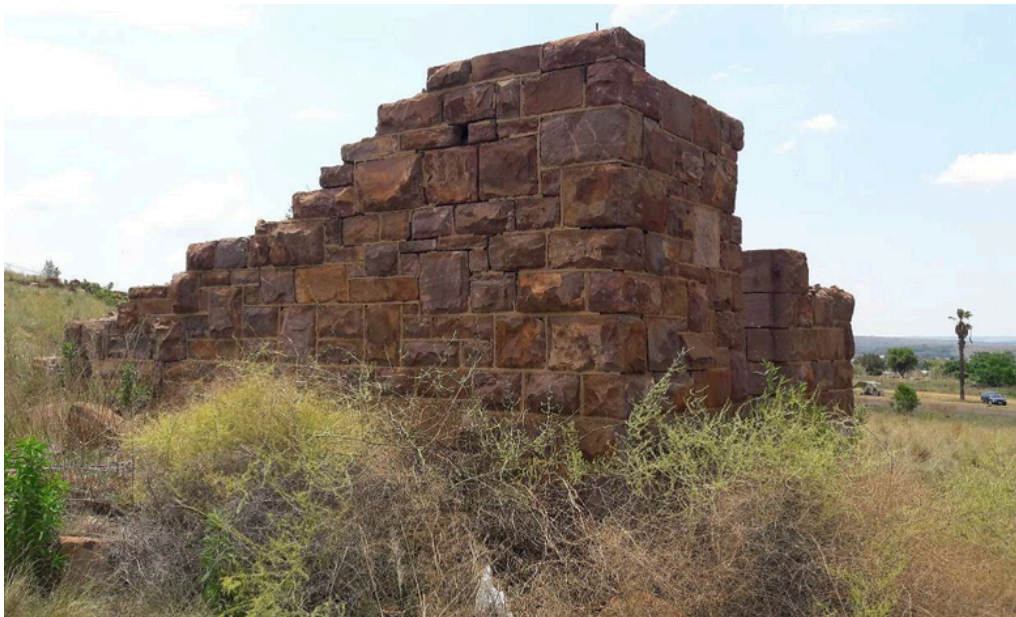
📷 FIGURE 1: RUINS OF THE POWDER STORE (PHOTO: THEO LIGTHELM 2017)

The Kruithuis building was undamaged until the 1970s, after which it was unfortunately systematically vandalised, and residents drove away from the hewn stone for their gardens and braai facilities, while the steel door and corrugated iron sheets were looted. Middelburg Heritage has mounted a Blue Heritage Plaque on the ruin.

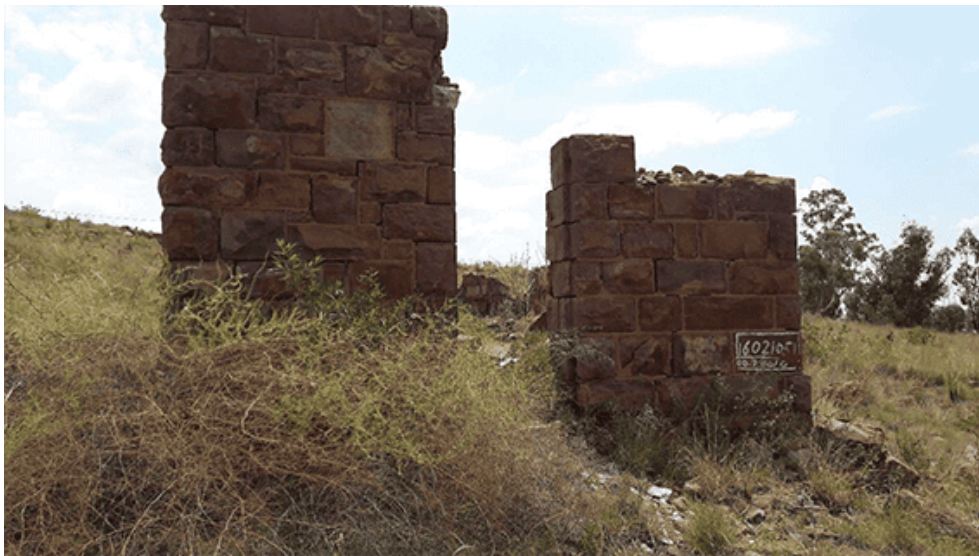
Figure 2: Position of the steel door on the eastern side of the building (Photo: Theo Ligthelm 2017)

The Powder Store was built on the western side of the town and consisted of a square stone building with ventilation holes in the walls. It had a tin roof with a thick steel door with several bolt points. The building of a Powder Store outside the town was due to the fear that the dynamite, gunpowder, and other ammunition stored in it might explode.

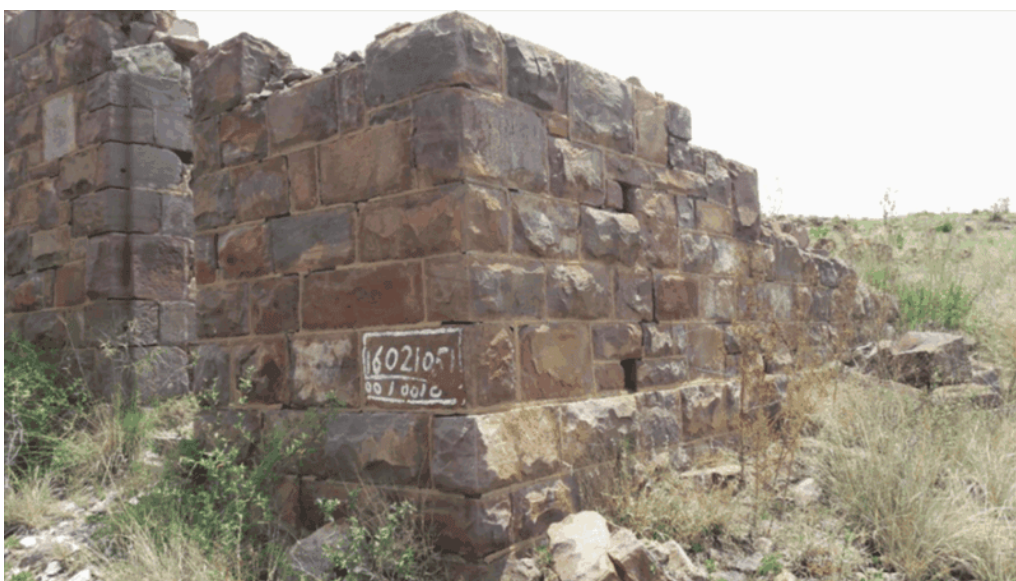
Figure 3: Ventilation holes in the walls – (these have been misinterpreted as loopholes, but have no wider area on the inside, which would therefore make pelleting with a weapon impossible) (Photo: Theo Ligthelm 2017)

It has sometimes been stated that the building was a Blockhouse from the Anglo-Boer War. Several experts agree that this was not the case. The symmetrical holes through the thick walls are also tunnels, which would make it impossible to aim a weapon at different angles of fire from the building.

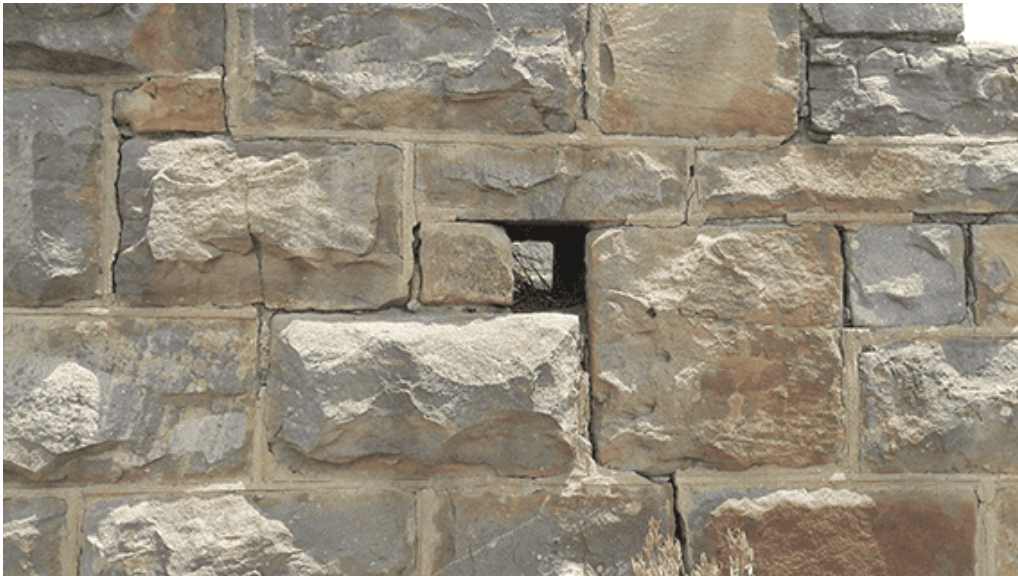
Figure 4: Ventilation holes in walls – (note tunnel design, so these could not have been Loopholes) (Photo: Theo Ligthelm 2017)
